## **PROJECT MANUAL – Book 2 of 2**

OES SECURITY UPGRADES

GOVERNOR'S OFFICE OF EMERGENCY SERVICES

MATHER, SACRAMENTO COUNTY, CALIFORNIA

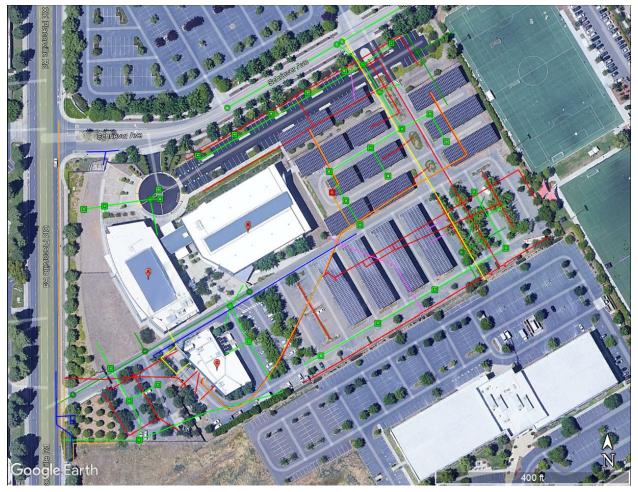
**Location 1 - All Utilities Detected**

The below exhibit captures all utilities detected within the location area(s) for detection activities performed on May 31 through June 3, and June 9 through June 10, 2022. Refer to the following sections for a description of each utility type. To facilitate reference to individual lines, lines have been labeled and numbered as described in this report in the associated KMZ file.

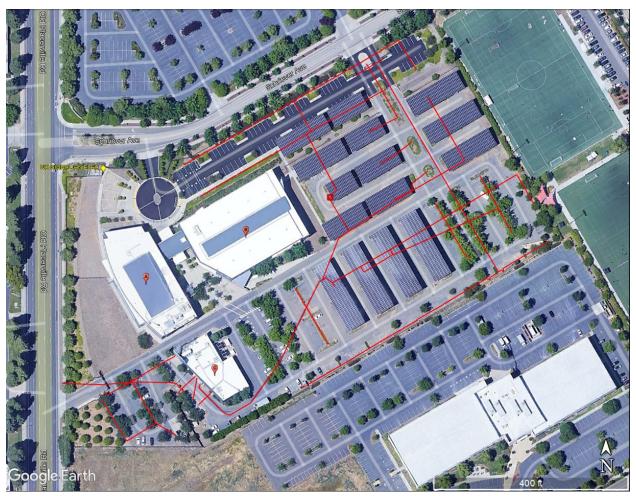
Location 1 – Electrical

E.1.1 Electrical: At this location fourteen electrical lines were detected. The first line begins at a utility pole on the east side of Old Placerville Road, north of the southwesterly driveway. This line travels easterly across the main drive aisle and southwesterly parking lot to what appears to be a transformer southwest of Building C, at an approximate depth between 48" and 60". The second line begins at a light pole on the south side of the main drive aisle, near the southwesterly driveway. This line travels southerly then northeasterly to the northwest corner of Building C, at an approximate depth of 30". The third line begins at a light pole at the northwest corner of the southwesterly-most driveway. This line travels southeasterly to a light pole at the southwest corner of the parking lot, travels northeasterly to a light pole at the south side of the central landscaped median of the parking lot, then travels northwesterly to a light pole at the north side of this landscaped median. At the pole that is at the south side of the medial, this line wyes and travels southeasterly to a light pole at the southeast corner of this parking lot. This line travels at an approximate depth of 30". The fourth line begins at what appears to be a transformer southwest of Building C. This line travels northeasterly to Building C, at an approximate depth of 48". The fifth line begins in the median between Building C and the southwesterly-most parking lot, south of electrical line four (described above). This line travels northerly to Building C. The sixth line begins at what appears to be a cabinet in the median between Building C and the southwesterly-most parking lot, south of electrical line five (described above). This line travels northeasterly to Building C, at an approximate depth of 31". The seventh line begins at the west side of Building C. This line travels southeasterly then easterly along the drive aisle around the south side of Building C, then travels northeasterly across the parking lots east of Building C to the solar panel arrays that are southeast of Building B, then wyes. The first wye segment travels southeasterly then northeasterly through the solar panel arrays south of the main drive aisle and continues northeasterly across the southeasterly most parking lot to the easterlymost planter, then travels southeasterly along the planter. At the second solar panel from the west, this segment tees, travels southeasterly then northeasterly through the remaining solar panels, and continues northeasterly to the east-most landscaped median in the southeasterly parking lot, then travels northwesterly/southeasterly along this median connecting a series of light poles. The second wye segment travels northeasterly across the main drive aisle to the solar arrays east of Building B, travels northeasterly along the south side of these solar arrays to the northeasterly most solar arrays, then travels northwesterly through the northeasterly most solar arrays. At the southwesterly-most solar panel in the arrays east of Building B, this line tees and travels northwesterly to an electrical box in the landscaped median on the west side of the shorter

section of solar arrays, travels northeasterly then northwesterly to the northwest-most solar panel, then tees and travels northeasterly to a light pole in the landscaped median south of the northeasterly driveway, and travels southwesterly through a series of light poles along the back of sidewalk on the north side of Building B. At the northwest-most solar panel, this tee segment tees and travels northwesterly across the northerly parking lot, then tees and travels southwesterly through a series of light poles along the north side of the north parking lot, and northeasterly across the northeasterly driveway to a light pole north of the northeasterly-most parking lot, then southeasterly to a light pole on the south side of the northeasterly-most parking lot. This line travels at an approximate depth of 48" between Building C and the solar arrays, and an approximate depth between 30" and 40" in and around the solar arrays and parking lots. The eighth line begins at a light pole in the southerly most landscaped planter, approximately 100' east of the southeast corner of Building C. This line travels northeasterly, through a series of light poles, along the south landscaped planter and south-most row of parking stalls, to a light pole at the southeast corner of the facility. Approximately 115' southwest of the southeast corner of the facility, this line tees and travels northwesterly through the central landscaped median of the southeasterly-most parking lot and continues northwesterly along the drive aisle to a point near the northeasterly driveway, where our locator lost signal on this line. This line travels at an approximate depth between 30" and 40". The ninth line begins at the landscaped median in the parking lot that is southeast of Building B and travels northwesterly/southeasterly along this median. The tenth line begins at the west-most landscaped median at the southeasterly-most parking lot and travels northwesterly/southeasterly along this median. The eleventh line begins at the southeast solar panel of the arrays directly northeast of Building B. This line travels northeasterly to a light pole in the southeasterly-most round landscaped median between the two drive aisles that travel to the northeasterly driveway. The twelfth line begins at the solar panel north of the panel where electrical line eleven (described above) begins. This line travels northeasterly to a light pole in the central round landscaped median between the two drive aisles that travel to the northeasterly driveway. The thirteenth line begins at the solar panel that is north of the panel where electrical line twelve (described above) begins. This line travels northeasterly to the northerly landscaped median between the two drive aisles that travel to the northeasterly driveway, then travels northwesterly to the concrete median at the northeasterly driveway. The fourteenth line begins at the concrete median at the northeasterly driveway. This line travels northeasterly and southwesterly across the east and west driveway drive aisles.

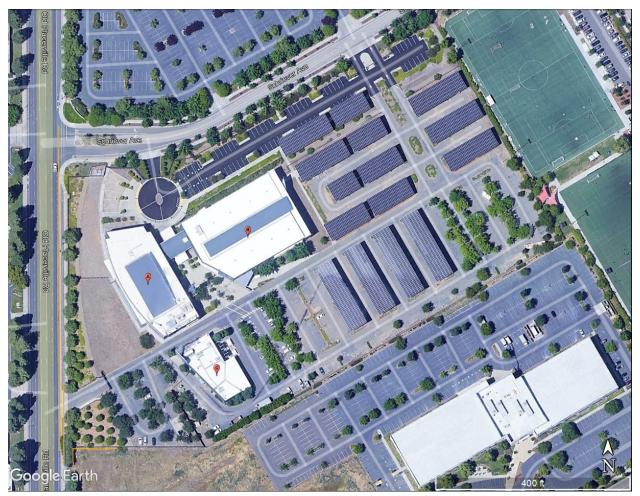
**Location 1 – Communication**

E.1.2 Telecommunication: At this location four communication lines were detected. The first line begins in the east side of Old Placerville Road, north of Schriever Avenue. This line travels southerly along the east shoulder of Old Placerville Road to the southerly limits of the utility detection area, at an approximate depth of 48". The second line begins at a utility pole that is north of the southwesterly driveway. This line travels southerly along the sidewalk to the southerly limits of the utility detection area. The third line begins in the field south of the OES facility, east of Old Placerville Road, at the southerly limits of the utility detection area. This line travels northerly to the south side of the southerly fence line, then travels easterly for approximately 85' feet where our locator lost signal on this line. The third line begins at the west side of Building C. This line travels southeasterly to the drive aisle, then travels easterly then northeasterly, across the parking lots east of Building C, to the north side of the central drive aisle, travels northeasterly to the south side of the northeasterly-most solar panel arrays, then travels northwesterly to the north side of this solar panel array. At the southwest side of the solar panel array that is east of Building B, this line tees and travels northwesterly to the northwest side of this solar panel array. This line travels at an approximate depth between 31" and 48".

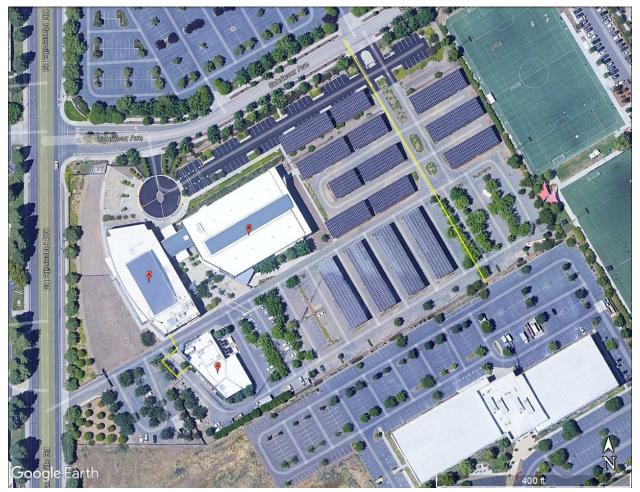
Location 1 - Gas

<u>E.1.3 Gas/Oil/Steam/HC</u>: At this location two gas lines were detected. The first line begins on the west side of Building C. This line travels southwesterly across the drive aisle, travels northwesterly then northeasterly to the north side of Building C, then travels northwesterly to the south side of Building A, at an approximate depth of 36". The second line begins in Schriever Avenue. This line travels southeasterly along the westerly drive aisle at the northeasterly driveway and continues southeasterly across the facility to the southerly limits of the utility detection area, at an approximate depth between 40" and 48".

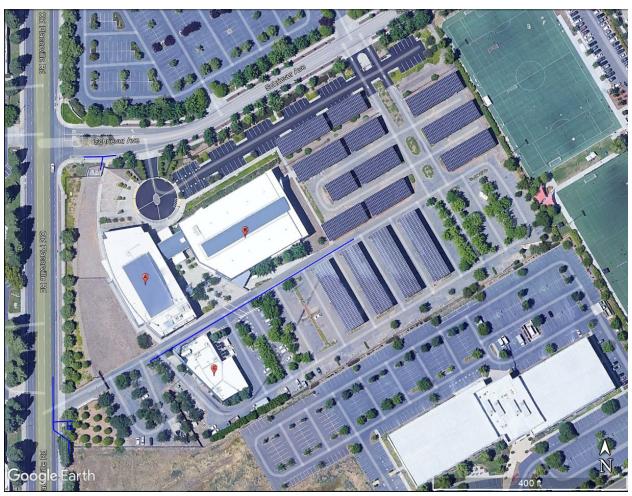
Location 1 - Water

E.1.4 Water: At this location three water lines were detected. The first line begins in the northbound lanes of Old Placerville Road, north of the southwesterly driveway. This line travels southerly along Old Placerville Road, travels southeasterly to the dirt behind the sidewalk, then travels southerly to the southerly limits of the utility detection area. South of the southwesterly driveway, this line tees and travels easterly to the landscaped area south of the southwesterly driveway, then splits into three segments. Our locator noted they lost signal on these three segments near the westerly side of the landscaped area. The second line begins in the eastbound bike lane of Schriever Avenue. This line travels easterly/westerly along Schriever Avenue. Approximately 100' east of Old Placerville Road, this line tees and travels southerly to a valve assembly in the northwest corner of the OES facility property. The third line begins in the central northeasterly/southwesterly drive aisle, at a planter west of Building C. This line travels northerly then northeasterly along the drive aisle to a point approximately 90' east of the southeast corner of Building B. Our locator noted they lost signal on this line at the southwest and northeast ends of the line.

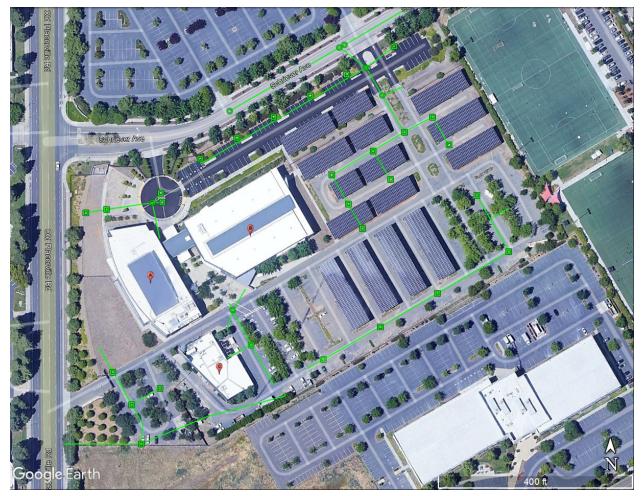
**Location 1 – Storm Drain**

E.1.5 Storm Drain / Sewer: At this location five storm drain lines were detected. The first line begins at the east side of Old Placerville Road, south of the southwesterly driveway. This line travels easterly along the southerly fence line to a catch basin at the south side of the southwesterly parking lot, then travels northeasterly to a landscaped median southeast of Building C. At the catch basin, this line wyes and travels northerly then northwesterly to a catch basin in the westerly drive aisle of the southwesterly parking lot, then tees. One segment travels northwesterly to a catch basin in the curb on the north side of the central drive aisle, and continues northwesterly. The other segment travels northeasterly to a catch basin in the easterly drive aisle of the southwesterly parking lot. The second line begins at a manhole in the central drive aisle between Building A, B and C. This line exits the manhole to the northeast to Building B, to the southwest to Building A, to the northwest between Buildings A and B, and to the southeast, traveling along the drive aisle on the east side of Building C, passing through a catch basin, and continuing southeast to the north side of the drive aisle that is south of Building C. At the catch basin, this line tees and travels southwesterly to Building C. The third line begins in the drive aisle that is south of Building C, approximately 115' east of the southeast corner of Building C. This line travels northeasterly along the drive aisle, passing through a series of catch basins, and continues to a catch basin south of the middle drive aisle at the southeasterly most parking lot, then travels northwesterly along this drive aisle to another catch basin. In the middle of this drive aisle, this line tees and travels northeasterly to the landscaped median between the parking stalls. The fourth line begins at a manhole in the traffic circle at the northwest side of the facility. This line exits the manhole to the northeast and to the east, traveling to catch basins in the median of the traffic circle; to the south traveling to Building A, and to the west, traveling through a catch basin north of Building A and continuing to a catch basin northwest of Building A. At the basin that is north of Building A, this line tees and travels southerly to the landscaped planter north of Building A. The fifth line begins at a manhole in Schriever Avenue, between the northwesterly and northeasterly driveways. This line travels northeasterly along Schriever Avenue, passes through two manholes near the northeasterly driveway, and continues northeasterly. At the westerly of the two manholes near the northeasterly driveway, this line wyes, travels southeasterly to a manhole in the westerly drive aisle of the northeasterly parking lot, continues southeasterly, passes through a manhole and continues southeasterly to a catch basin, then tees, connecting a series of catch basins throughout the solar panel arrays that are northeast of Building B. At the manhole that is in the northeasterly driveway, this line tees and

travels northeasterly and southwesterly along the northmost row of parking stalls, connecting a series of catch basins.

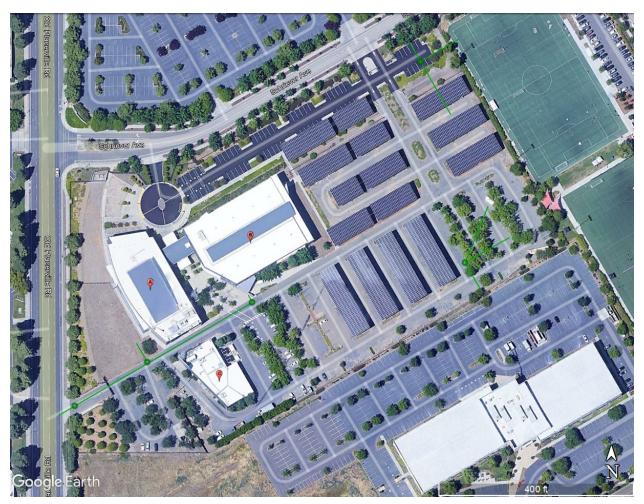
**Location 1 – Sewer**

Three sewer lines were detected at this location. The first line begins in Old Placerville Road near the southwesterly driveway. This line travels northeasterly along the main drive aisle, passes through a clean out at the southwesterly driveway, passes through a manhole south of Building A, and continues northeasterly to a manhole south of Building B, then travels northwesterly to Building B. At the manhole south of Building A, this lien travels northwesterly into the dirt west of Building A. The second line begins at a manhole in the northeasterly-most parking lot. This line exits the manhole to the northwest toward Schriever Avenue; to the northeast toward the tennis courts, and to the southeast to northeasterly-most solar panel arrays, where our locator lost signal on this line. Our locator noted that there appeared to be no flow in this manhole. The third line begins at a manhole in the southeasterly-most parking lot. This line exits the manhole to the northeast, to the east, and to the southeast. Our locator noter this line appears to be abandoned.

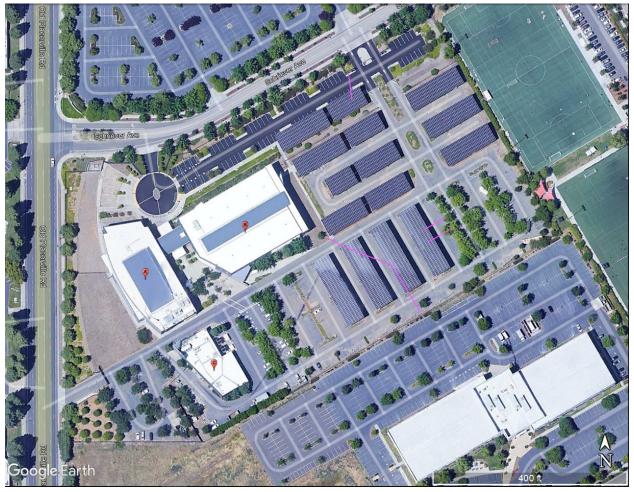
Location 1 - Unknown

<u>E.1.6 Unknown/Undefined Utilities and Features</u>: At this location four unknown lines were detected. The first line begins in the landscaped planter on the west side of the northeasterly driveway. This line travels southerly across the drive aisle to the adjacent solar panel array, at an approximate depth of 35". The second line begins in the landscaped area on the southeast side of Building B. This line travels east southeasterly to the solar panel arrays, then southeasterly to the southerly fence line. The third and fourth lines begin in the westerly drive aisle of the southeasterly-most parking lot. These lines travel northeasterly/southwesterly across this drive aisle.

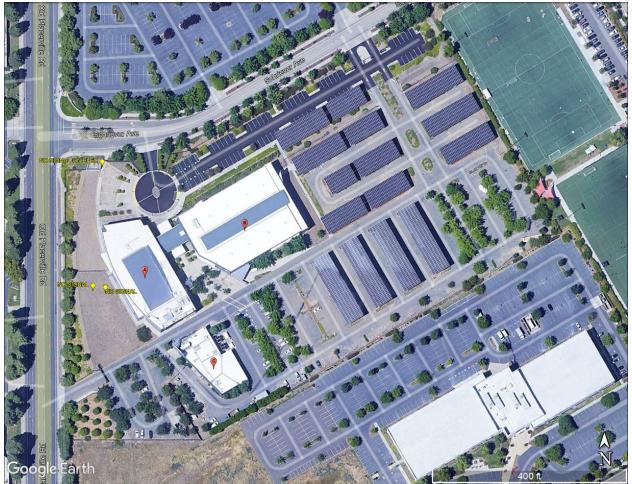
Location 1 – Additional Notes

<u>E.1.7 Additional Notes:</u> Our locator observed two boxes in the dirt west of Building A but were unable to obtain a signal on any lines in these boxes. Our locator also observed an electrical box in the concrete pathway east of the water valve assembly at the northwest corner of the facility but was unable to obtain a signal on any lines in this box.

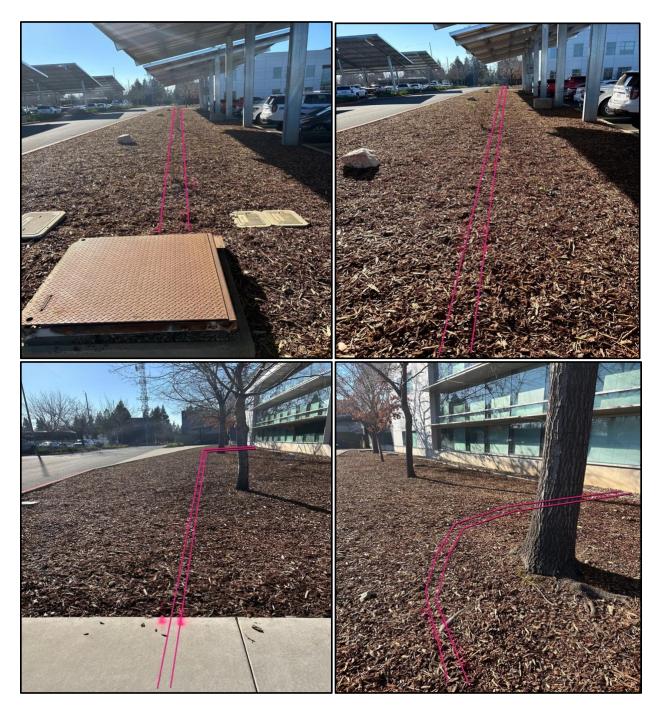
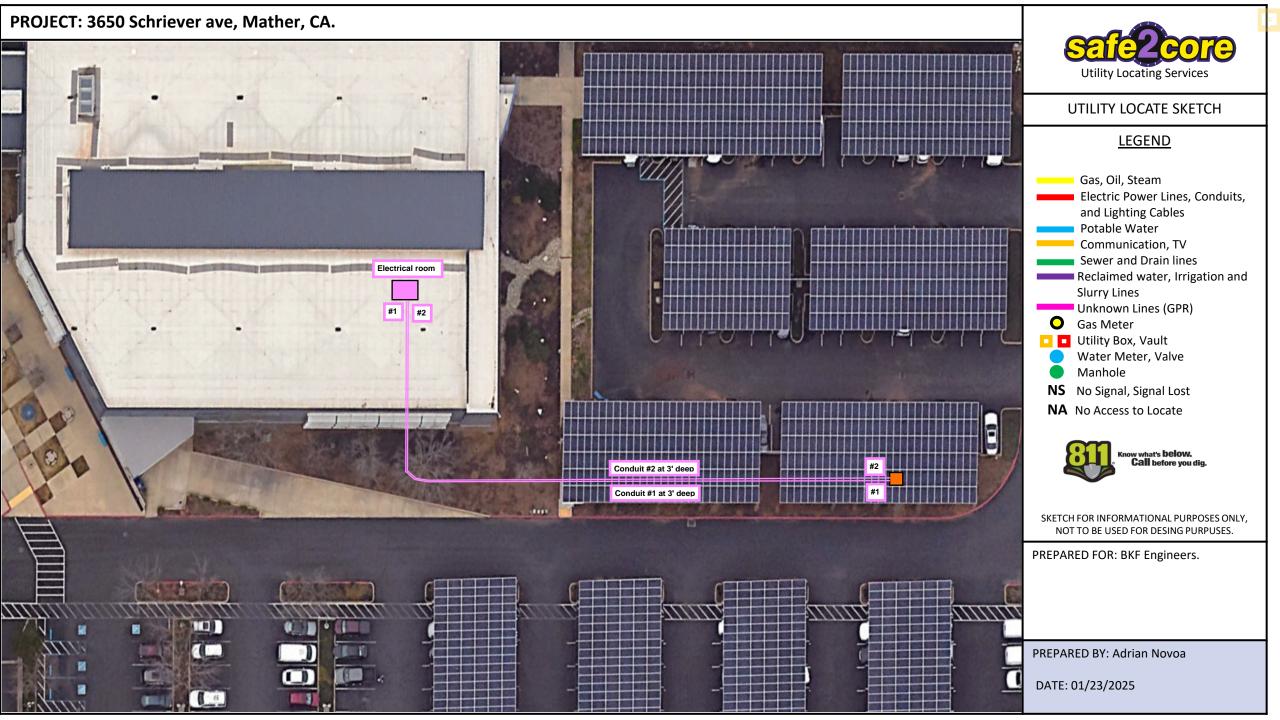
Marked Routing: Visible surface markings indicating conduit paths.
