PUBLIC COMMENT on PROPOSED BUILDING STANDARDS

Public Comment on Proposed Building Standards
Title 24, Part 5, Section 715.3

A Retrospective Evaluation of Cured-in-Place Pipe (CIPP) Used in Municipal Gravity Sewers

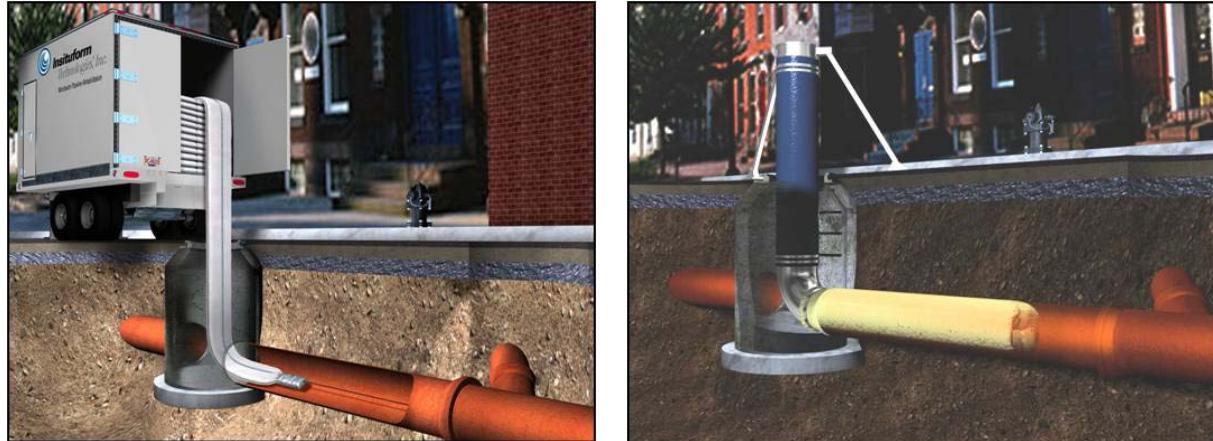
Figure 2-2. CIPP Installation Options: Liner Pull-in (Left) and Liner Inversion (Right)
(Courtesy Insituform Technologies, Inc.)

When the impregnated liner is ready, it is introduced into the host pipe to be relined. This can be done by inversion of the liner along the host pipe using water or air pressure or by pulling the liner into place and then inflating it to a close fit using water or air (see Figure 2-2).

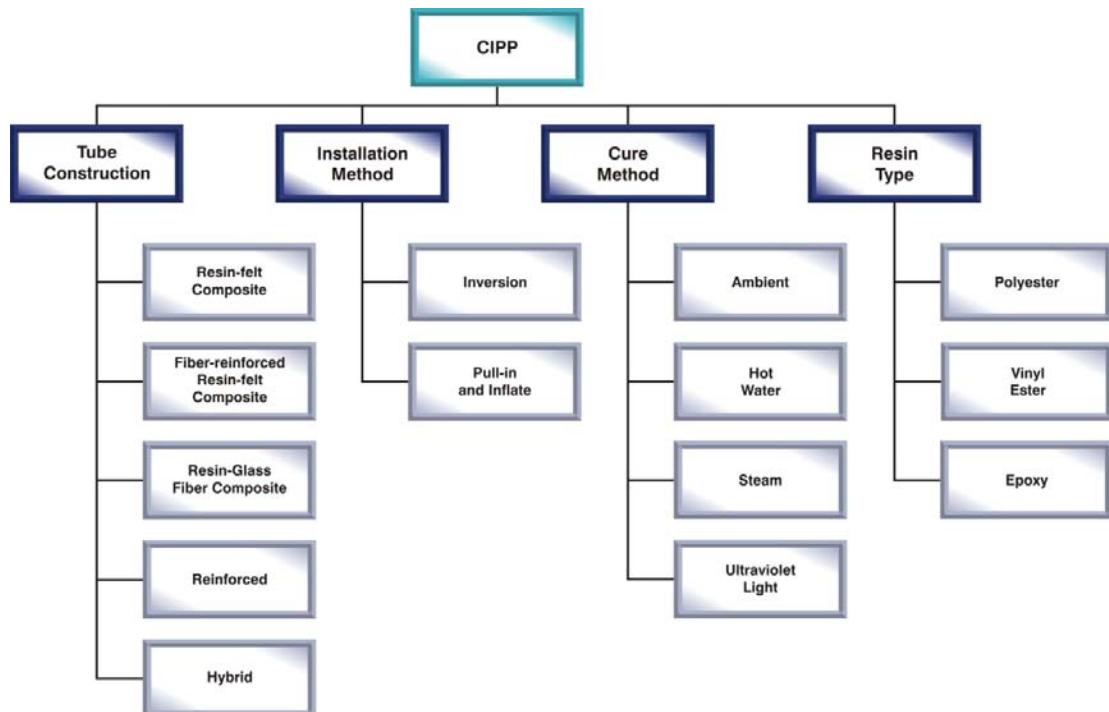
Figure 2-3. Summary of Common CIPP Technologies

Figure 2-3 highlights the main differences in CIPP technologies available today based on tube construction, method of installation, curing method, and type of resin. The original CIPP product was a needle-felt tube, impregnated with polyester resin that was inverted into a sewer through a manhole and cured using hot water. This product is still used for gravity sewers.

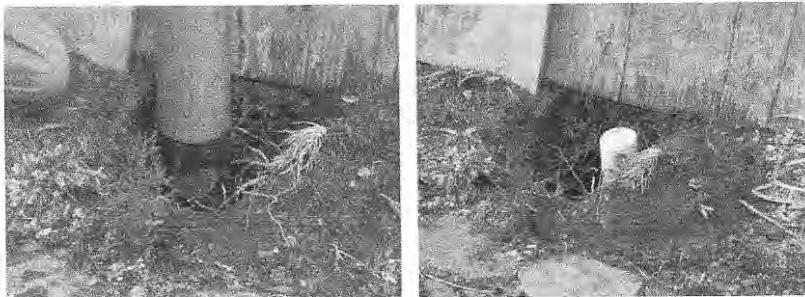
Figure A-17. New Cleanouts. Left: Pit Hydro Excavating. Right: Installed Vac-A-Tee® Cleanout.

Installation of Cleanouts on Laterals Where Necessary. Hydro excavation was utilized to make excavations for new cleanouts (Figure A-17). The soil was cut with a water jet and vacuumed out with a 6" tube connected to the vacuum truck. The pit size was about 18" in diameter. Such a small excavation was adequate because a lateral saddle assembly product would be used, which snaps onto an existing lateral pipe and requires only a small foot print compared to a typical cleanout installation. It took on average 60 minutes to complete one pit.

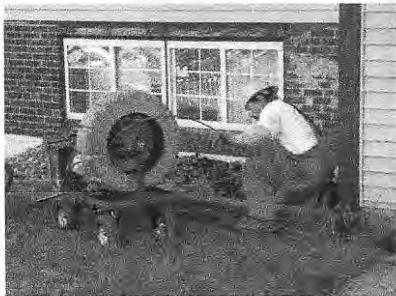
Figure A-20. Inserting the Lateral CCTV Camera into the Lateral.

Once the lines were prepared, a small lateral CCTV camera was inserted through the cleanout near the house into the lateral (Figure A-20). The camera was pushed downstream close to the mainline. The camera would provide accurate robotic positioning of the T-liner and document the inversion process on a video recording equipment.

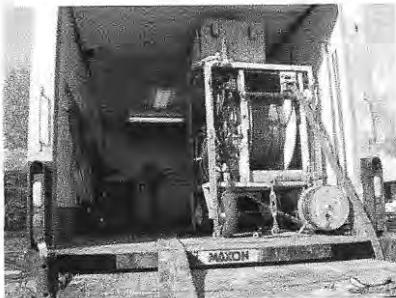
Figure A-21. Truck Used as a Mobile Wet-out Unit.

The truck was used as a mobile wet-out unit (Figure A-21). The red hose shown in the picture is the launching device. It is a flexible steam inflatable device that works in all mainline pipe sizes. The resin was mixed first, then poured into the tube and vacuum impregnated (Figure A-22). The mixed resin was poured into the tube through the end that will be installed upstream, near the house. The opposite end of the tube with a short mainline section was connected to a vacuum hose. The resin was spread inside the tube utilizing vacuum impregnation. The person in the figure on right was checking the vacuum impregnation making sure that the thickness of the saturated tube was as specified.

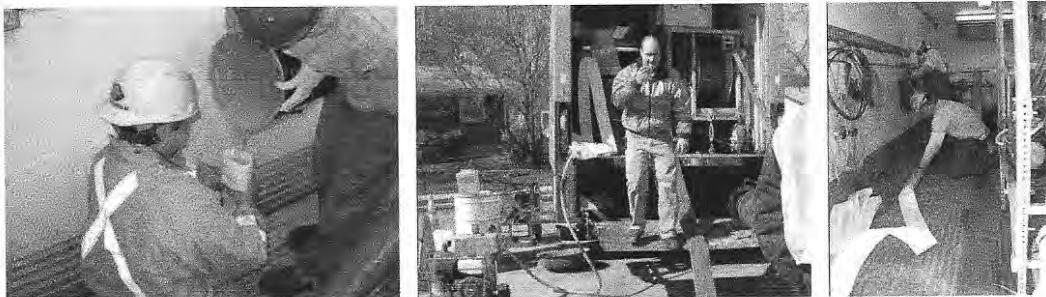
Figure A-22. Liner Impregnation with Resin. Left: Pouring the Resin into the Tube. Middle: Vacuum Hose Connected to the Tube. Right: Vacuum Impregnation.

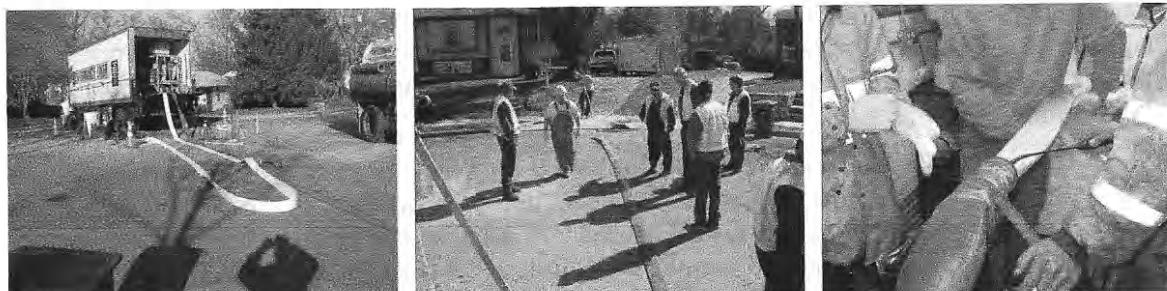
Figure A-23. Pulling the Liner/Bladder Assembly into the Launcher. Left: Both Tubes Laid Out on the Ground. Middle: Pulling the Cable Inside the Launcher. Right: The Assembly Entering the Launcher.

Loading of the Launcher. The liner/bladder assembly containing the resin-saturated tube was next pulled into the launcher (Figure A-23). Both tubes were laid out on the ground next to the truck. Inside the truck, one end of the launcher (through which a cable was stringed) was affixed onto a piece of pipe and the assembly connected to the cable. As the person outside was pulling the cable, the tube was entering the launcher. The resin remained on the inside of the tube. The loading of the launcher was completed by affixing the short mainline section onto the launcher (Figure A-24). Hydrophilic bands were added.

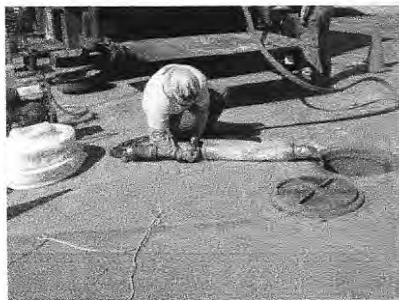
Figure A-24. Completing the Loading of the Launcher.

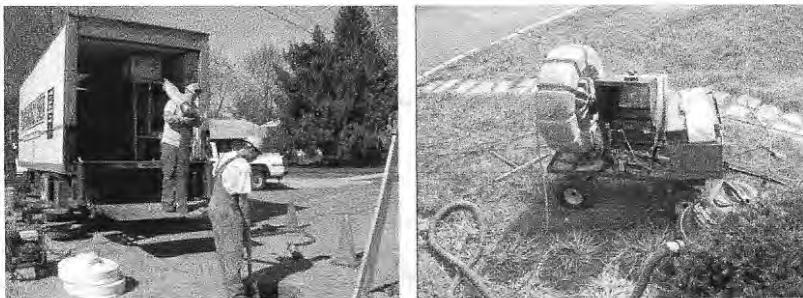
Figure A-25. Positioning of the Launcher. Left: Insertion through the Manhole. Right: Lateral CCTV Camera.

Inversion of the Liner. The loaded launcher was first positioned inside the mainline to enable inversion of the liner/bladder assembly into the lateral (Figure A-25). The end of the launcher opposite of mainline section was inserted through the manhole first. Once the launcher was completely inside the mainline, it was winched past the lateral connection until its end with the mainline section was positioned exactly at the connection. The CCTV camera inside the lateral was used to monitor the positioning of the launcher.

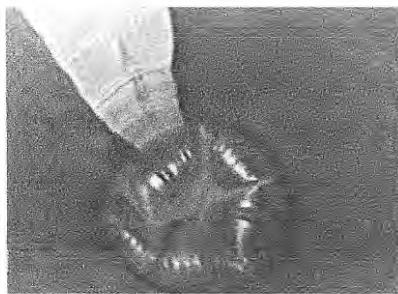
Figure A-26. Air Inversion of the Liner/Bladder Assembly into the Lateral.

Air pressure was applied causing the liner/bladder assembly to invert up into the lateral pipe, on some laterals as far as 85' (Figure A-26). Once in place, the air pressure held the bladder/liner assembly tightly against the lateral pipe.

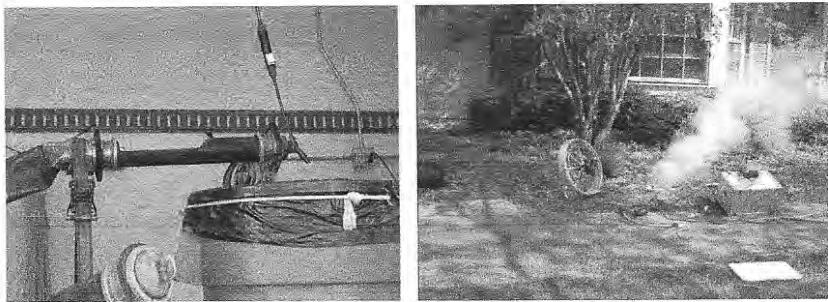
Figure A-27. Resin Cure. Left: Steam Hose Connected to the Bladder. Right: Steam Exiting at the Cleanout Near the House.

Resin Curing. Steam was used for resin curing (Figure A-27). The steam tank was connected with the bladder and steam introduced into it. The resin curing took about 30 minutes. During that time, the steam was circulating through the bladder and exiting out of the lateral at the cleanout near the house. The upstream end of the bladder was left slightly open. Once the resin curing was completed, the bladder was pulled out.

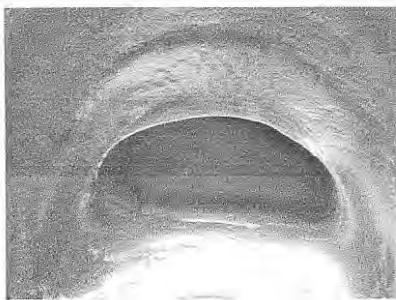
Figure A-28. Installed T-liner at the Lateral-to-mainline Connection (a View from the Mainline).

Post CCTV Inspection. The installed liner was inspected with both lateral and mainline CCTV. Figure A-28 shows the relined lateral connection viewed from inside the mainline.
