VULNERABILITY OF THE EAVE TO DIRECT FLAME CONTACT AND RADIANT EXPOSURES

Stephen L. Quarles*, University of California Cooperative Extension, Richmond, CA 94804

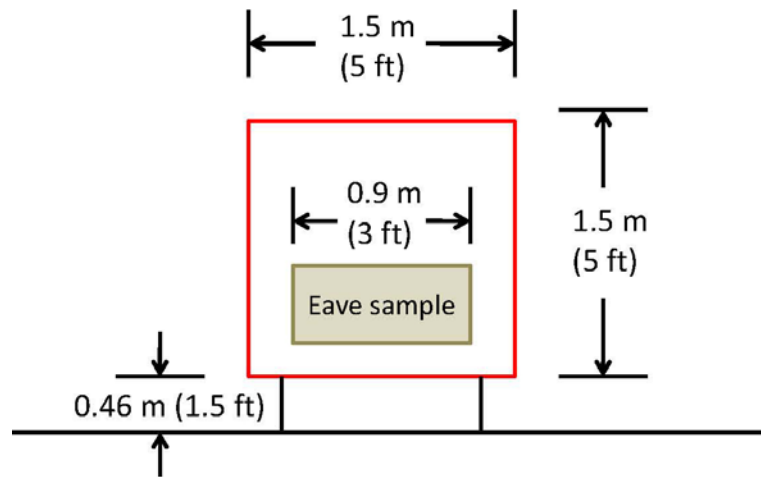
Figure 3. The 915 mm (3 ft) wide open- and soffited-eave samples were centered in front of the 1.5 by 1.5 m (5 by 5 ft) radiant panel.
