VULNERABILITY OF THE EAVE TO DIRECT FLAME CONTACT AND RADIANT EXPOSURES

Stephen L. Quarles*, University of California Cooperative Extension, Richmond, CA 94804

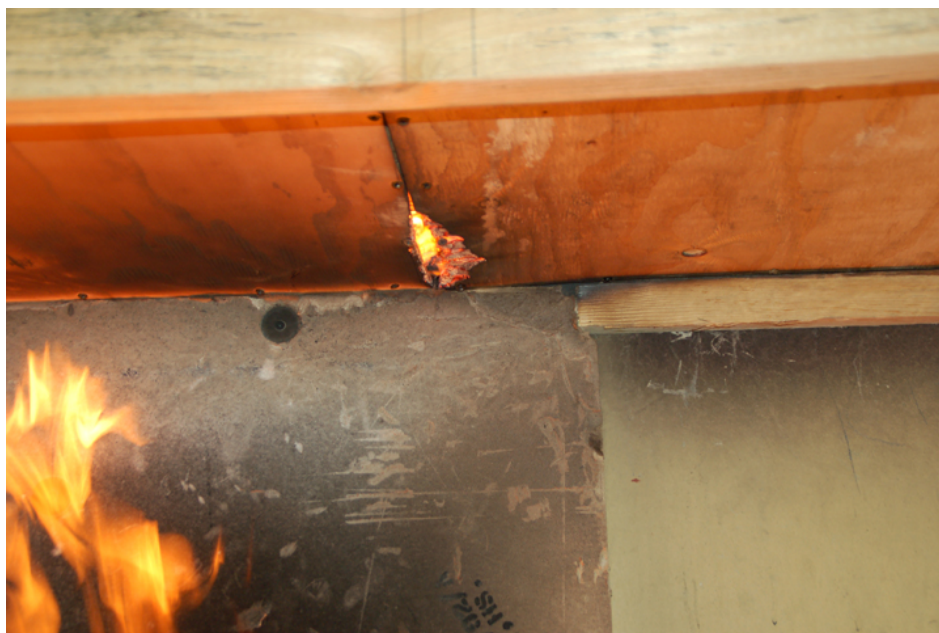
Figure 5. Flame penetration at a between-panel joint allowing for flame propagation to occur within the enclosed soffit cavity. This test was terminated prior to ignition of the soffit material and flame propagation to the fascia.

Flaming ignition of the soffit material and subsequent flame spread out to the fascia did not occur in the second replication of the 460 mm (18 in) soffited-eave test, resulting in the missing data point in Table 2. Flame spread to the fascia did not occur because of flame penetration at a joint between two soffit panels (Figure 5). The test was ended when flame began to propagate within the soffited eave. Flame penetration to the non-fire exposed side of the wall occurred occasionally with both open- and soffited-eave walls. Penetration always occurred at a joint. In soffited-eave construction, flame penetration at a joint allowed fire to enter the enclosed area and spread laterally within the soffited-eave and also into

the attic space. Use of a batten strip at joints in a soffit-eave could delay flame penetration. Specific board and batten designs have been approved for use in wildfire prone areas in California ⁹, indicating that a batten of a particular width and thickness can resist penetration at between-board joints in board-and-batten cladding when subjected to a direct flame contact exposure. In open-eave construction, flame penetration typically occurred at the edge or end of the blocking, most often at the lower edge or end allowing flames to penetrate into the attic space. Flame penetration occasionally occurred at the top edge of the blocking, at the plywood-to-OSB joint, which would provide a flame contact exposure to the underside of the roof covering material. In all cases, these examples provide examples of the importance and vulnerability of joints typically found in construction to direct flame exposure.

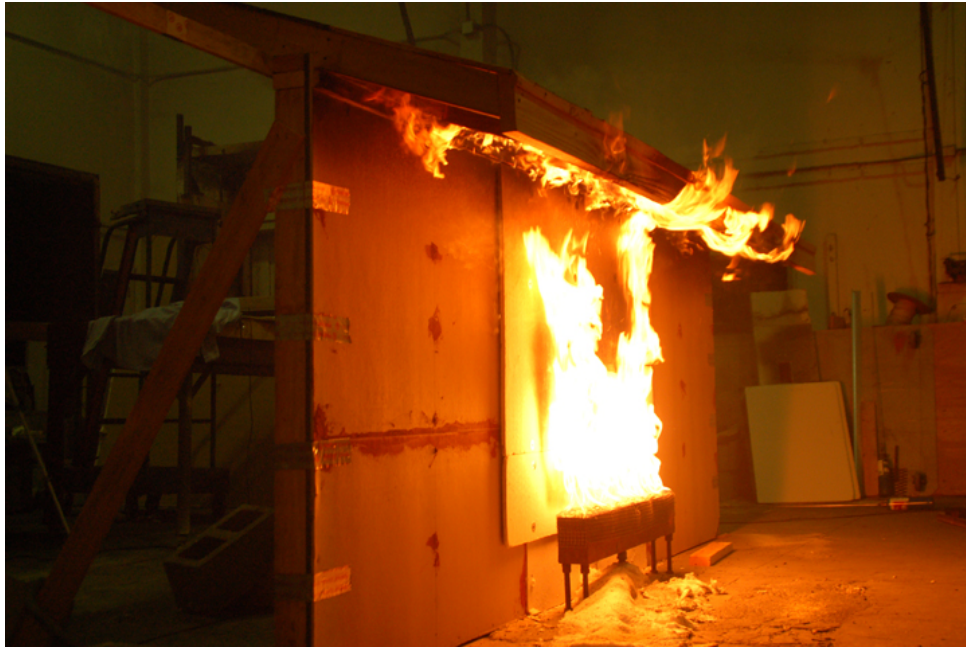
Figure 6. Lateral flame spread in the open-eave specimens usually spread to the end of the test wall within 30 to 60 s.

In addition to ignition time, the propensity of the flame to spread laterally along the wall was observed. Whereas the time required for flame to spread laterally along the wall varied somewhat, it consistently occurred in open-eave construction, usually spreading to the ends of the wall, or near it, within 30 to 60 s (Figure 6). Lateral flame spread in the soffit-eave specimens was not as extensive, and usually did not spread far onto the plywood surface in the adjacent wall sections. In both open- and soffit-eave specimens, flaming combustion often subsided in charred areas while the burner flame was still on (Figure 7).

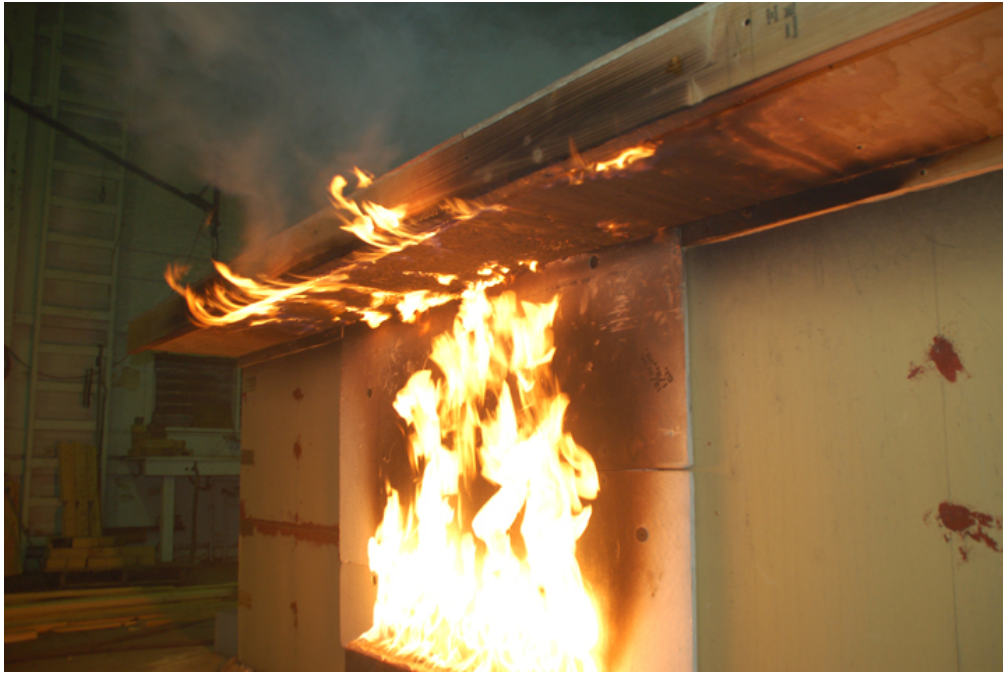
Figure 7. Lateral flame spread was not as extensive in the soffited-eave specimens. In both open- and soffited-eaves specimens, flaming combustion often subsided in charred areas, as shown here. Flaming combustion is more active at the fascia-to-soffit intersection. Flaming in this area was likely enhanced by the addition of a small trim piece that was attached to the soffit material, behind the fascia

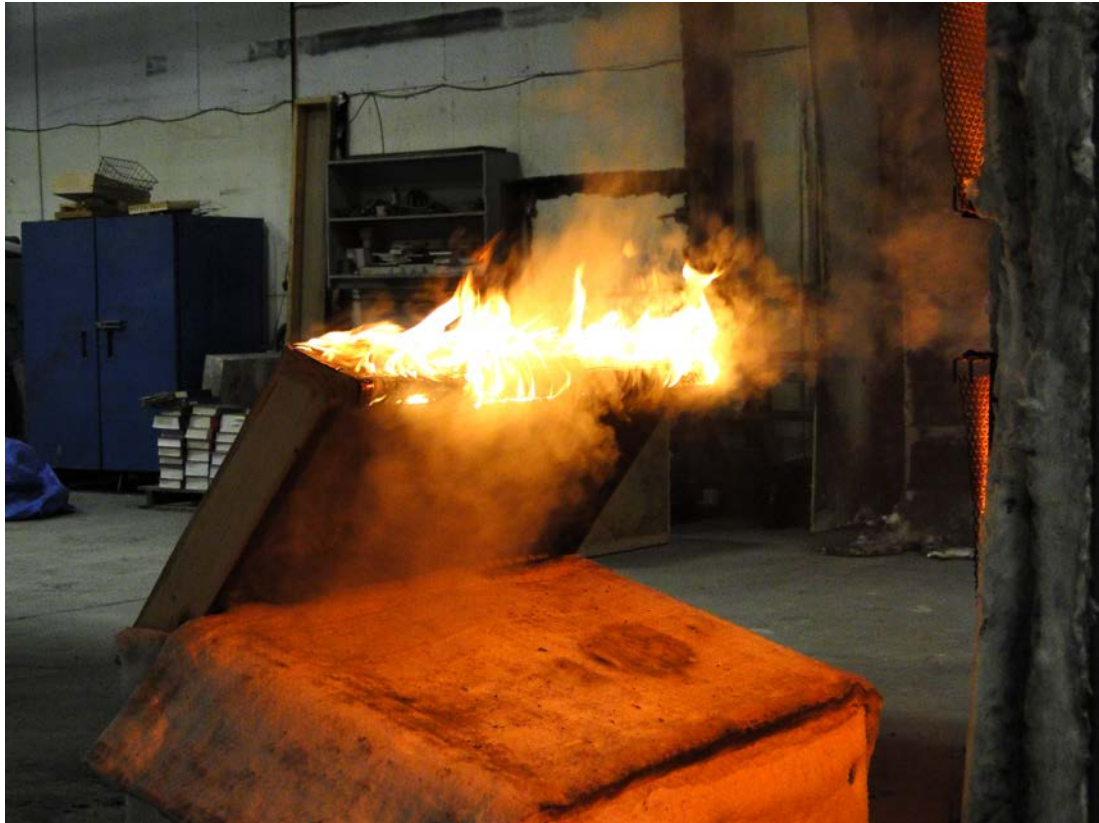
Figure 8. Flaming ignition at the fascia in an open-eave specimen exposed to a $20\text{kW}/\text{m}^2$ radiant exposure.
