PROJECT MANUAL – Book 2 of 3

APPENDICES: HAZARDOUS MATERIALS REPORTS,
STRUCTURAL ASSESSMENT

DEMOLITION 345 ASH & 1301 STATE STREET

RE: Limited Asbestos and Lead-Containing Hazardous Materials Survey Report
Former San Diego Transamerica Building (804)
1301 State Street, San Diego, California 92101

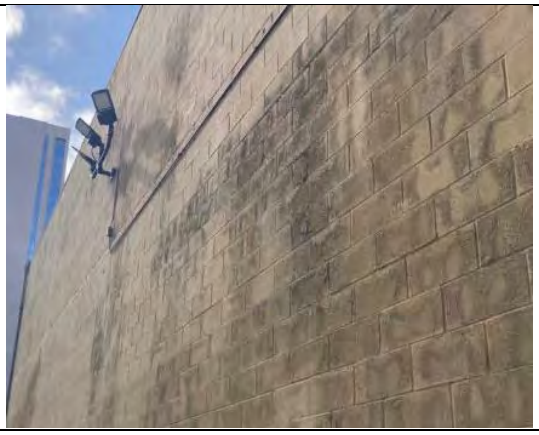
Photo of HA number 2, ACM Multi Color Exterior Stucco, within Exterior 1301

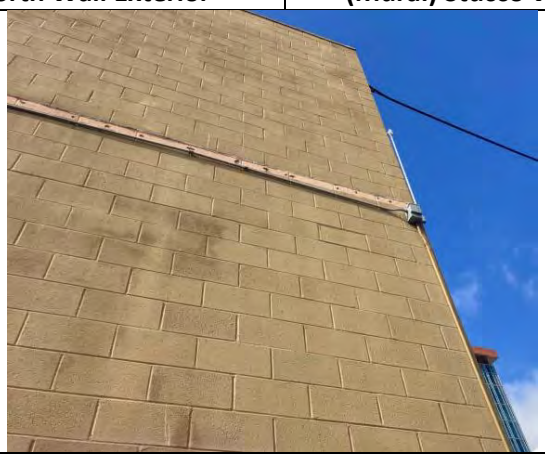
Photo of HA number 1107-03, LCM Multicolor (Mural) Stucco Wall, within the West End

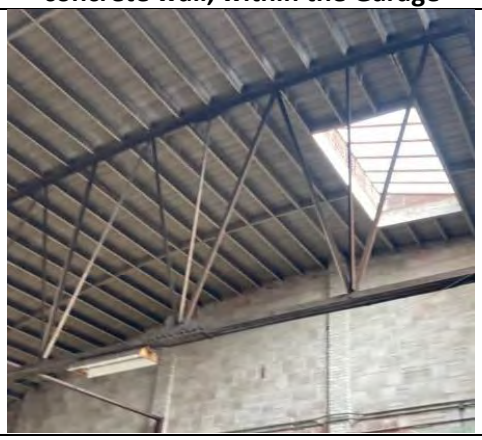
All PCB-containing devices, including, but not limited to ballasts, should be removed or have the oils removed and properly handled, collected, stored, transported and recycled or disposed of by an approved recycling or disposal facility in accordance with the requirements of Title 22 CCR 67426.1.

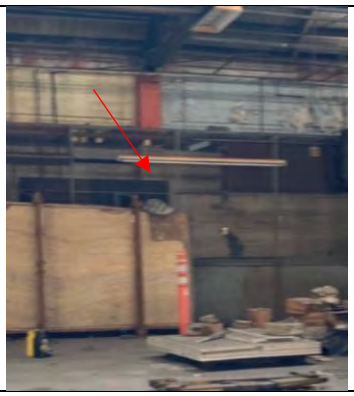
Notification to employees and contractors working within the buildings should be made in accordance with the California Health and Safety Code, Section 25915 et. seq. and Proposition 65 as appropriate to the material in question.

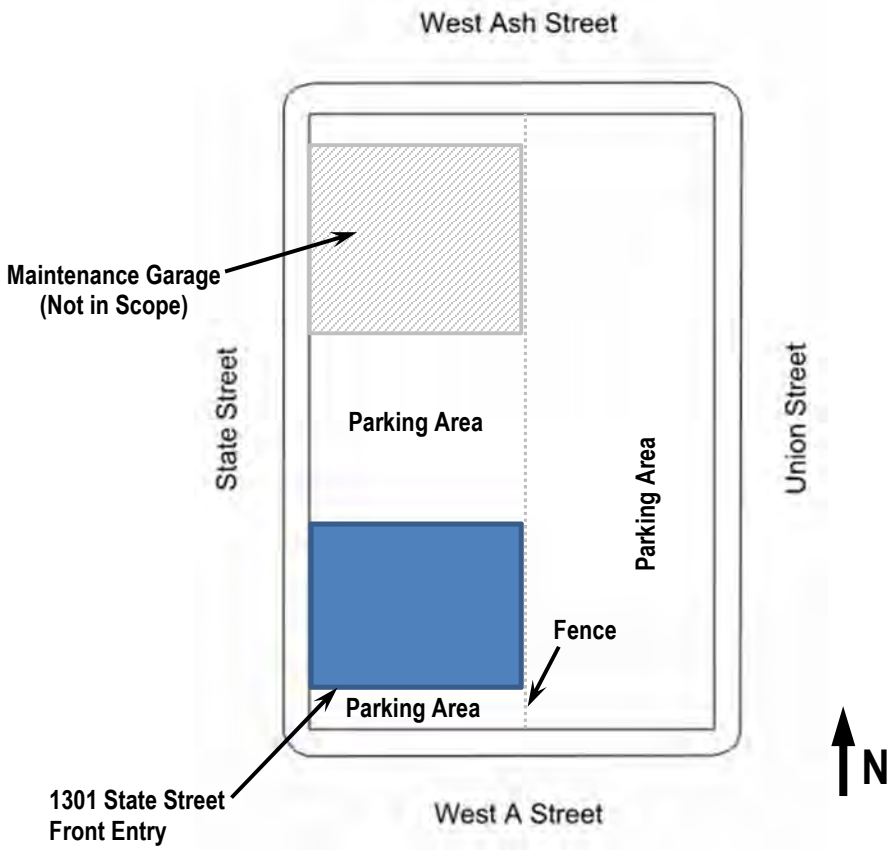
Figure 1: Plan View of Site

The building sits on a relatively flat lot at the corner of State and West A streets as shown in Figure 1 below. At grade parking lots abut the building on three sides. A public sidewalk abuts the west side of the building. The building has been vacant since at least 2007 and is currently planned for demolition.

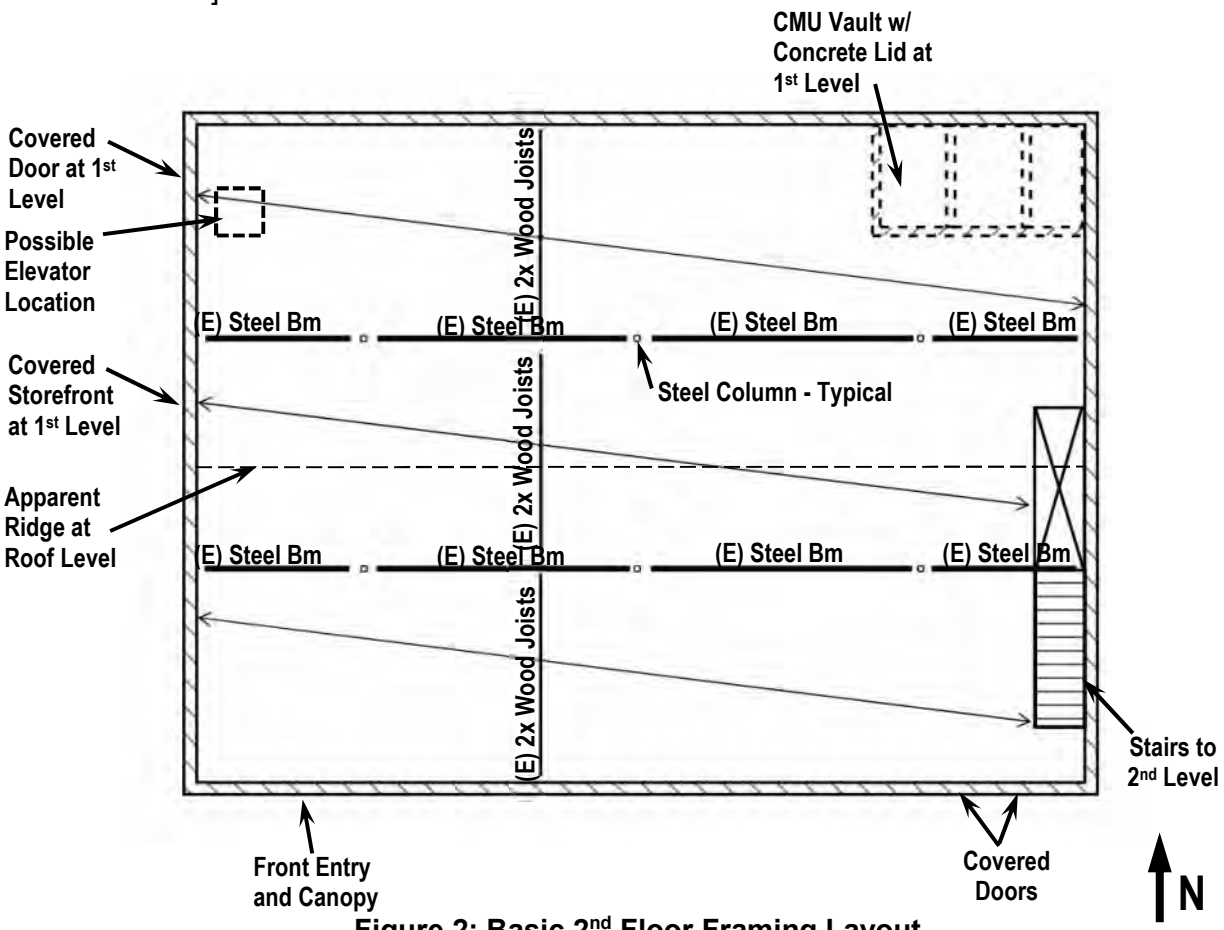
Figure 2: Basic 2nd Floor Framing Layout

The building is a two-story concrete masonry (CMU) wall structure that was reportedly constructed in 1959. It is rectangular in plan with overall dimensions of approximately 70 feet by 100 feet and a height of approximately 22 feet [see Figure 2 below]. It encloses an overall area of approximately 14,000 square feet. A CMU vault with a ribbed reinforced concrete lid exists in the northeast corner of the building at the first level.

The building's gravity load carrying systems include wood sheathing and sawn lumber joists for both the roof and floor that span to perimeter wood ledgers along the perimeter CMU walls and to a series of interior steel beams. At the roof, aerial imagery appears to show an east-west running ridge along the building's midline. This may suggest that the roof framing is supported by structural steel framing or perhaps tapered steel girders supported by the north and south perimeter building walls and possibly by the interior building columns. At the floor, the interior east-west running beams are supported by interior structural steel columns and CMU pilasters at their perimeter ends. Both the perimeter CMU walls and the interior columns are presumed to bear onto shallow concrete foundations.
