## **PROJECT MANUAL – Book 2 of 2**

OES SECURITY UPGRADES

GOVERNOR'S OFFICE OF EMERGENCY SERVICES

MATHER, SACRAMENTO COUNTY, CALIFORNIA

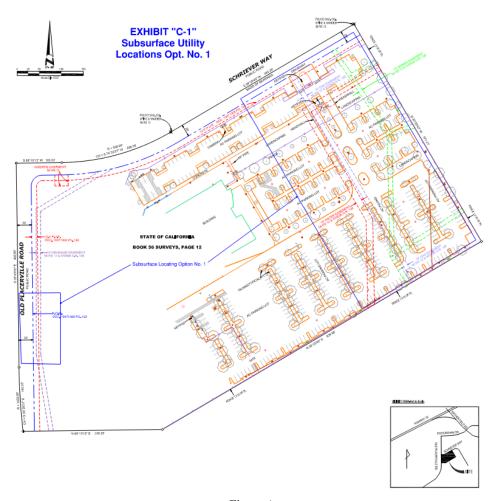
Figure A

C.1: Scope is to detect utilities within the Office of Emergency Services facility, located in Mather CA, and show below outlined in blue, cyan and red hatched areas in Figures A, B and C.

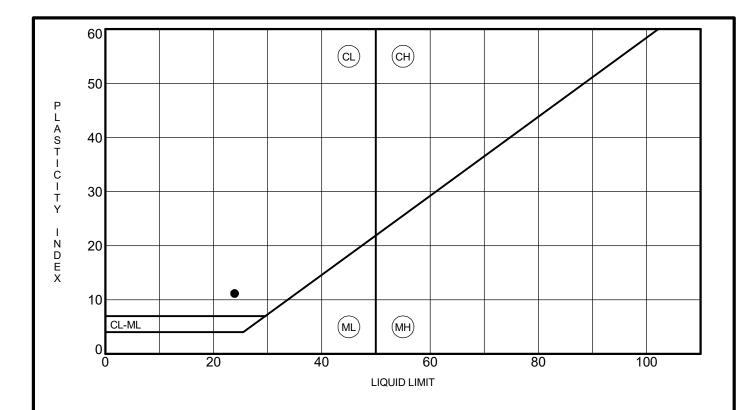
Figure: 8 Date:

We performed a laboratory Plasticity Index test on a representative near-surface sample which indicate medium plasticity. Plasticity Index test results are attached as Figure 8.

Sample No.	Liquid Limit	Plastic Limit	Plasticity Index	% Pass #200 Sieve	Unified Soil Classification Description	Preparation Method
•	Combo Bulk	24	13	11		Lean Clay	dry
