## **PROJECT MANUAL – Book 2 of 2**

**OES SECURITY UPGRADES**

**GOVERNOR'S OFFICE OF EMERGENCY SERVICES**

**MATHER, SACRAMENTO COUNTY, CALIFORNIA**

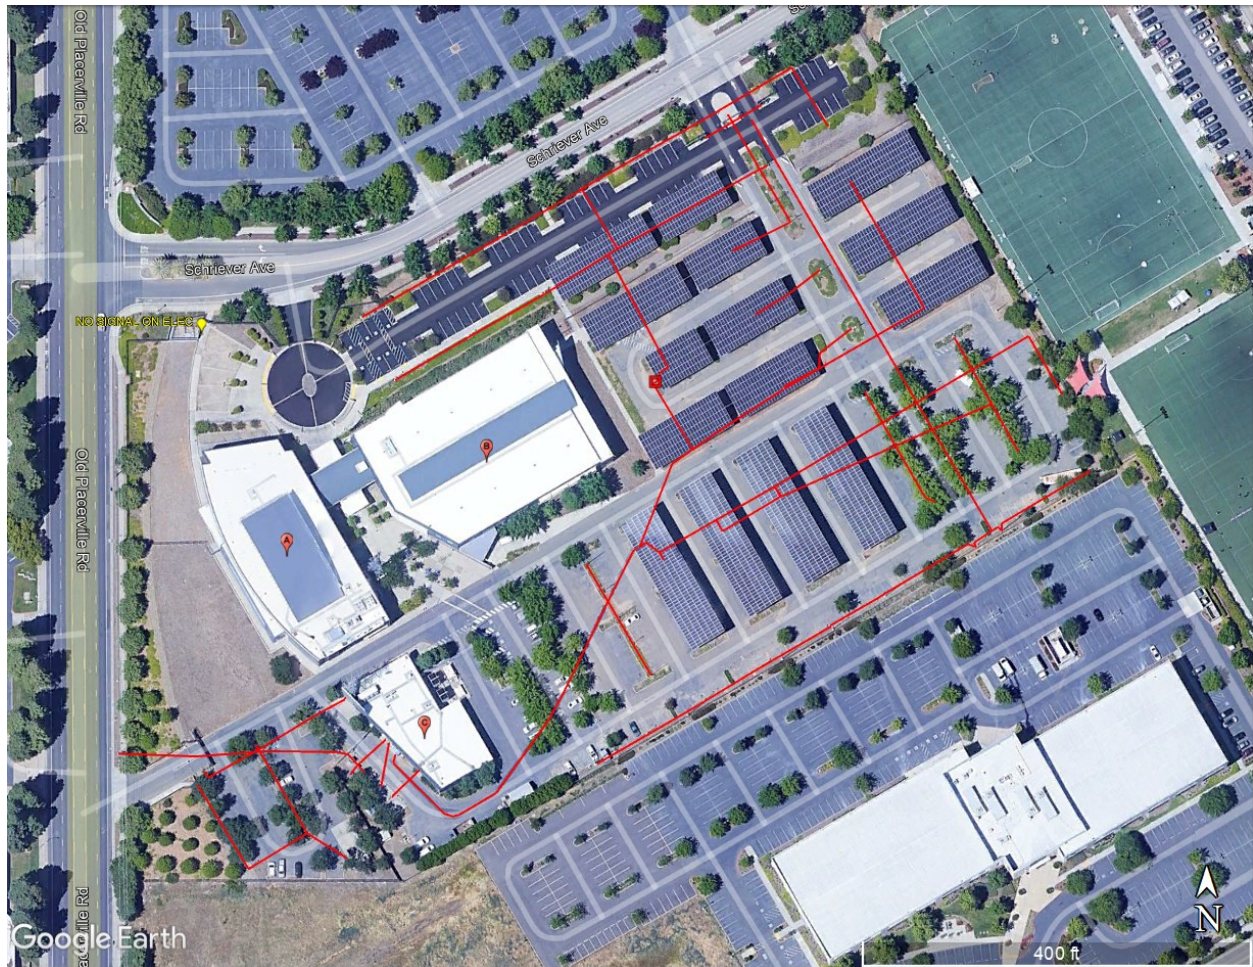
Location 1 – Electrical

E.1.1 Electrical: At this location fourteen electrical lines were detected. The first line begins at a utility pole on the east side of Old Placerville Road, north of the southwesterly driveway. This line travels easterly across the main drive aisle and southwesterly parking lot to what appears to be a transformer southwest of Building C, at an approximate depth between 48” and 60”. The second line begins at a light pole on the south side of the main drive aisle, near the southwesterly driveway. This line travels southerly then northeasterly to the northwest corner of Building C, at an approximate depth of 30”. The third line begins at a light pole at the northwest corner of the southwesterly-most driveway. This line travels southeasterly to a light pole at the southwest corner of the parking lot, travels northeasterly to a light pole at the south side of the central landscaped median of the parking lot, then travels northwesterly to a light pole at the north side of this landscaped median. At the pole that is at the south side of the medial, this line wyes and travels southeasterly to a light pole at the southeast corner of this parking lot. This line travels at an approximate depth of 30”. The fourth line begins at what appears to be a transformer southwest of Building C. This line travels northeasterly to Building C, at an approximate depth of 48”. The fifth line begins in the median between Building C and the southwesterly-most parking lot, south of electrical line four (described above). This line travels northerly to Building C. The sixth line begins at what appears to be a cabinet in the median between Building C and the southwesterly-most parking lot, south of electrical line five (described above). This line travels northeasterly to Building C, at an approximate depth of 31”. The seventh line begins at the west side of Building C. This line travels southeasterly then easterly along the drive aisle around the south side of Building C, then travels northeasterly across the parking lots east of Building C to the solar panel arrays that are southeast of Building B, then wyes. The first wye segment travels southeasterly then northeasterly through the solar panel arrays south of the main drive aisle and continues northeasterly across the southeasterly most parking lot to the easterly-most planter, then travels southeasterly along the planter. At the second solar panel from the west, this segment tees, travels southeasterly then northeasterly through the remaining solar panels, and continues northeasterly to the east-most landscaped median in the southeasterly parking lot, then travels northwesterly/southeasterly along this median connecting a series of light poles. The second wye segment travels northeasterly across the main drive aisle to the solar arrays east of Building B, travels northeasterly along the south side of these solar arrays to the northeasterly most solar arrays, then travels northwesterly through the northeasterly most solar arrays. At the southwesterly-most solar panel in the arrays east of Building B, this line tees and travels northwesterly to an electrical box in the landscaped median on the west side of the shorter

section of solar arrays, travels northeasterly then northwesterly to the northwest-most solar panel, then tees and travels northeasterly to a light pole in the landscaped median south of the northeasterly driveway, and travels southwesterly through a series of light poles along the back of sidewalk on the north side of Building B. At the northwest-most solar panel, this tee segment tees and travels northwesterly across the northerly parking lot, then tees and travels southwesterly through a series of light poles along the north side of the north parking lot, and northeasterly across the northeasterly driveway to a light pole north of the northeasterly-most parking lot, then southeasterly to a light pole on the south side of the northeasterly-most parking lot. This line travels at an approximate depth of 48" between Building C and the solar arrays, and an approximate depth between 30" and 40" in and around the solar arrays and parking lots. The eighth line begins at a light pole in the southerly most landscaped planter, approximately 100' east of the southeast corner of Building C. This line travels northeasterly, through a series of light poles, along the south landscaped planter and south-most row of parking stalls, to a light pole at the southeast corner of the facility. Approximately 115' southwest of the southeast corner of the facility, this line tees and travels northwesterly through the central landscaped median of the southeasterly-most parking lot and continues northwesterly along the drive aisle to a point near the northeasterly driveway, where our locator lost signal on this line. This line travels at an approximate depth between 30" and 40". The ninth line begins at the landscaped median in the parking lot that is southeast of Building B and travels northwesterly/southeasterly along this median. The tenth line begins at the west-most landscaped median at the southeasterly-most parking lot and travels northwesterly/southeasterly along this median. The eleventh line begins at the southeast solar panel of the arrays directly northeast of Building B. This line travels northeasterly to a light pole in the southeasterly-most round landscaped median between the two drive aisles that travel to the northeasterly driveway. The twelfth line begins at the solar panel north of the panel where electrical line eleven (described above) begins. This line travels northeasterly to a light pole in the central round landscaped median between the two drive aisles that travel to the northeasterly driveway. The thirteenth line begins at the solar panel that is north of the panel where electrical line twelve (described above) begins. This line travels northeasterly to the northerly landscaped median between the two drive aisles that travel to the northeasterly driveway, then travels northwesterly to the concrete median at the northeasterly driveway. The fourteenth line begins at the concrete median at the northeasterly driveway. This line travels northeasterly and southwesterly across the east and west driveway drive aisles.

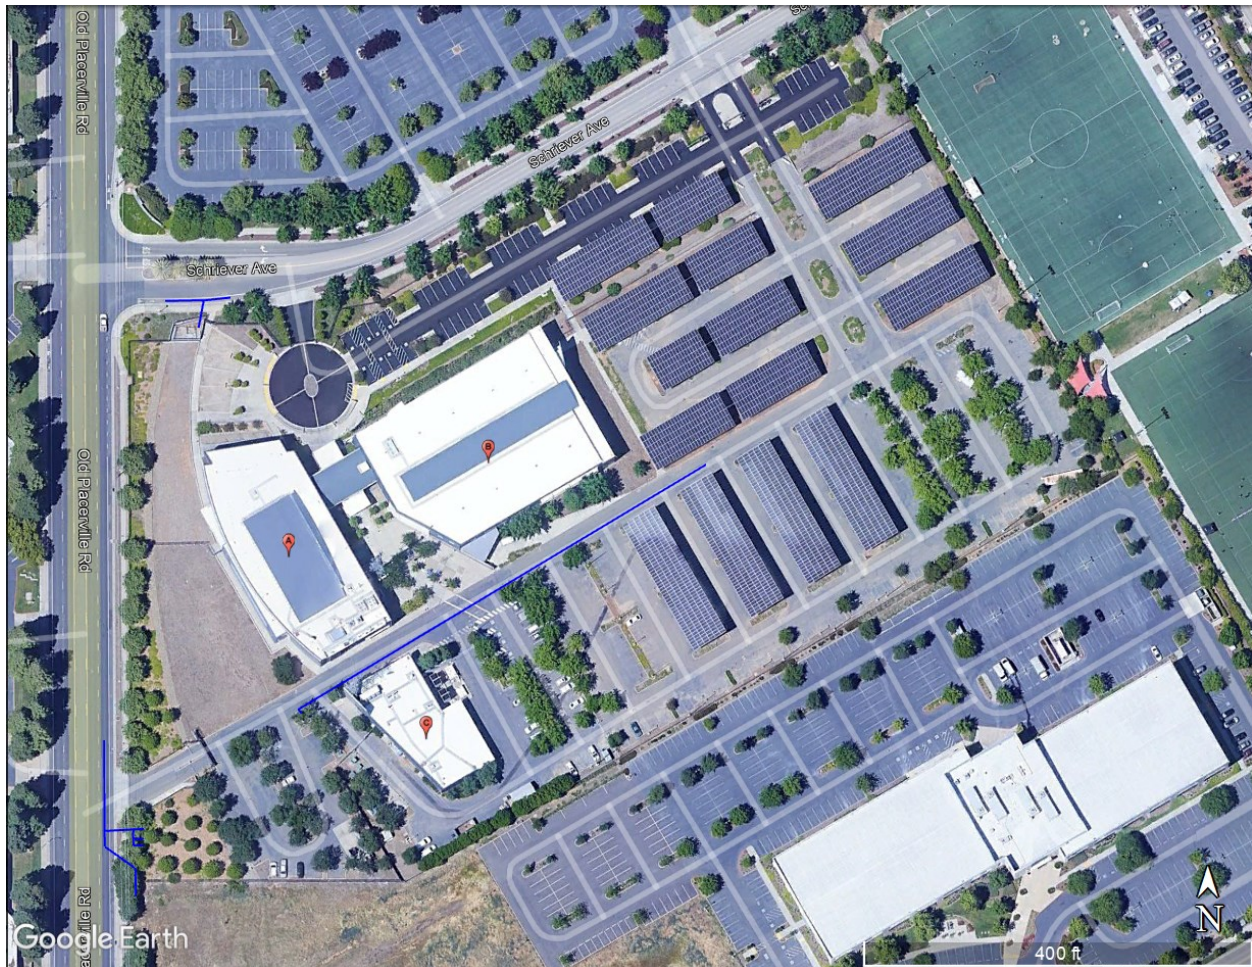
Location 1 – Water

E.1.4 Water: At this location three water lines were detected. The first line begins in the northbound lanes of Old Placerville Road, north of the southwesterly driveway. This line travels southerly along Old Placerville Road, travels southeasterly to the dirt behind the sidewalk, then travels southerly to the southerly limits of the utility detection area. South of the southwesterly driveway, this line tees and travels easterly to the landscaped area south of the southwesterly driveway, then splits into three segments. Our locator noted they lost signal on these three segments near the westerly side of the landscaped area. The second line begins in the eastbound bike lane of Schriever Avenue. This line travels easterly/westerly along Schriever Avenue. Approximately 100' east of Old Placerville Road, this line tees and travels southerly to a valve assembly in the northwest corner of the OES facility property. The third line begins in the central northeasterly/southwesterly drive aisle, at a planter west of Building C. This line travels northerly then northeasterly along the drive aisle to a point approximately 90' east of the southeast corner of Building B. Our locator noted they lost signal on this line at the southwest and northeast ends of the line.

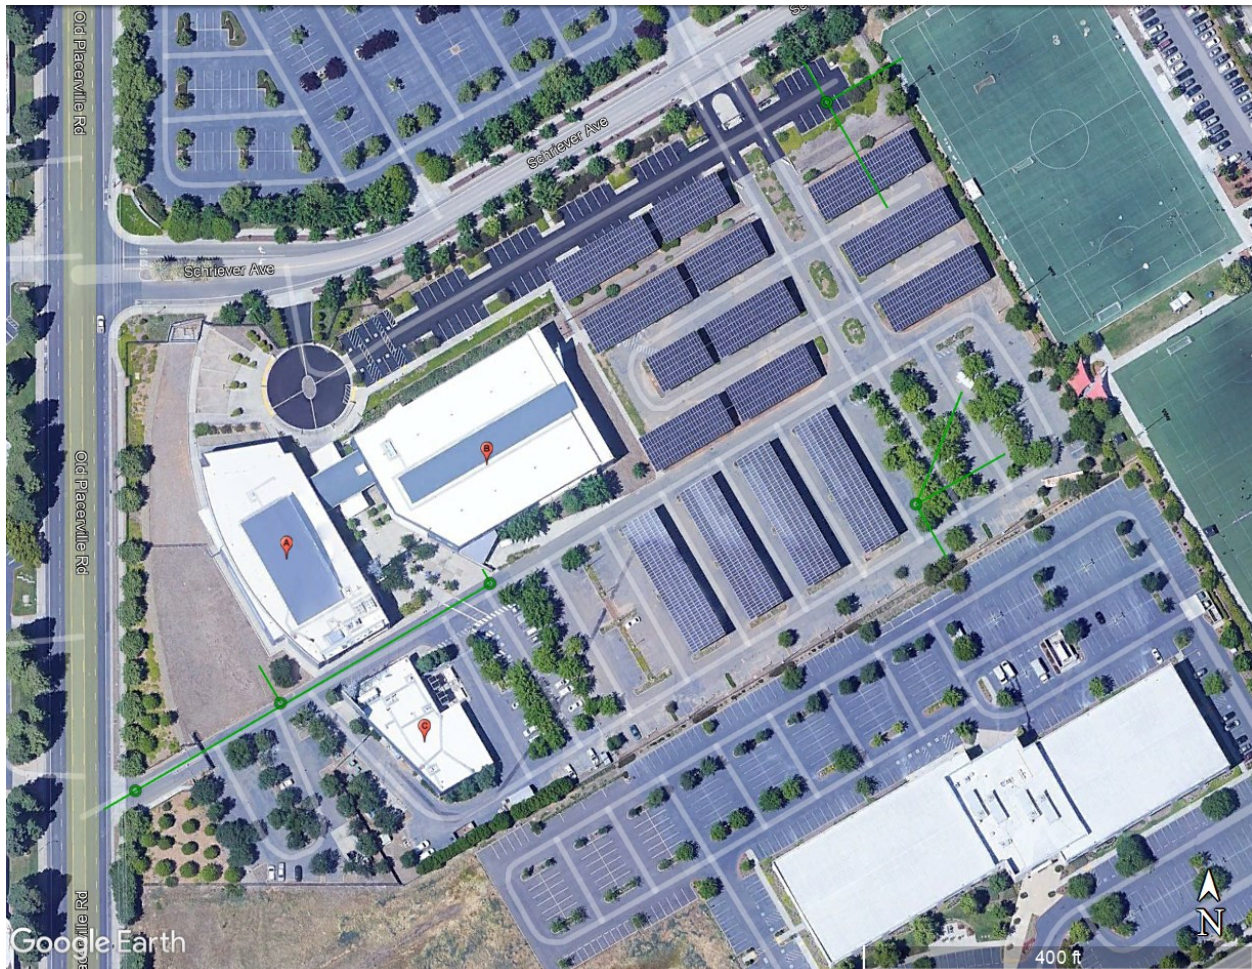
Location 1 – Sewer

Three sewer lines were detected at this location. The first line begins in Old Placerville Road near the southwesterly driveway. This line travels northeasterly along the main drive aisle, passes through a clean out at the southwesterly driveway, passes through a manhole south of Building A, and continues northeasterly to a manhole south of Building B, then travels northwesterly to Building B. At the manhole south of Building A, this line travels northwesterly into the dirt west of Building A. The second line begins at a manhole in the northeasterly-most parking lot. This line exits the manhole to the northwest toward Schriever Avenue; to the northeast toward the tennis courts, and to the southeast to northeasterly-most solar panel arrays, where our locator lost signal on this line. Our locator noted that there appeared to be no flow in this manhole. The third line begins at a manhole in the southeasterly-most parking lot. This line exits the manhole to the northeast, to the east, and to the southeast. Our locator notes this line appears to be abandoned.

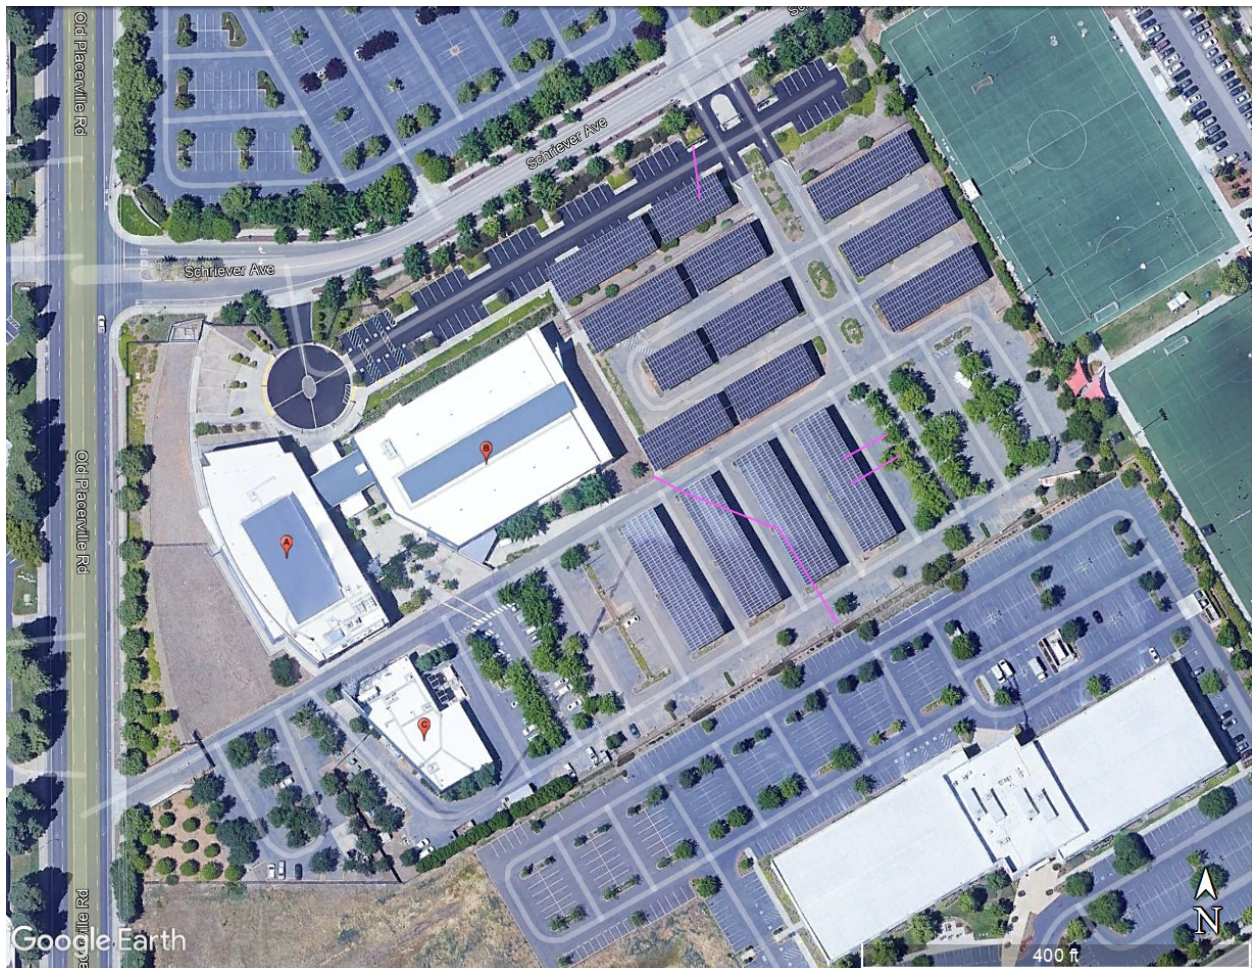
Location 1 – Unknown

E.1.6 Unknown/Undefined Utilities and Features: At this location four unknown lines were detected. The first line begins in the landscaped planter on the west side of the northeasterly driveway. This line travels southerly across the drive aisle to the adjacent solar panel array, at an approximate depth of 35". The second line begins in the landscaped area on the southeast side of Building B. This line travels east southeasterly to the solar panel arrays, then southeasterly to the southerly fence line. The third and fourth lines begin in the westerly drive aisle of the southeasterly-most parking lot. These lines travel northeasterly/southwesterly across this drive aisle.

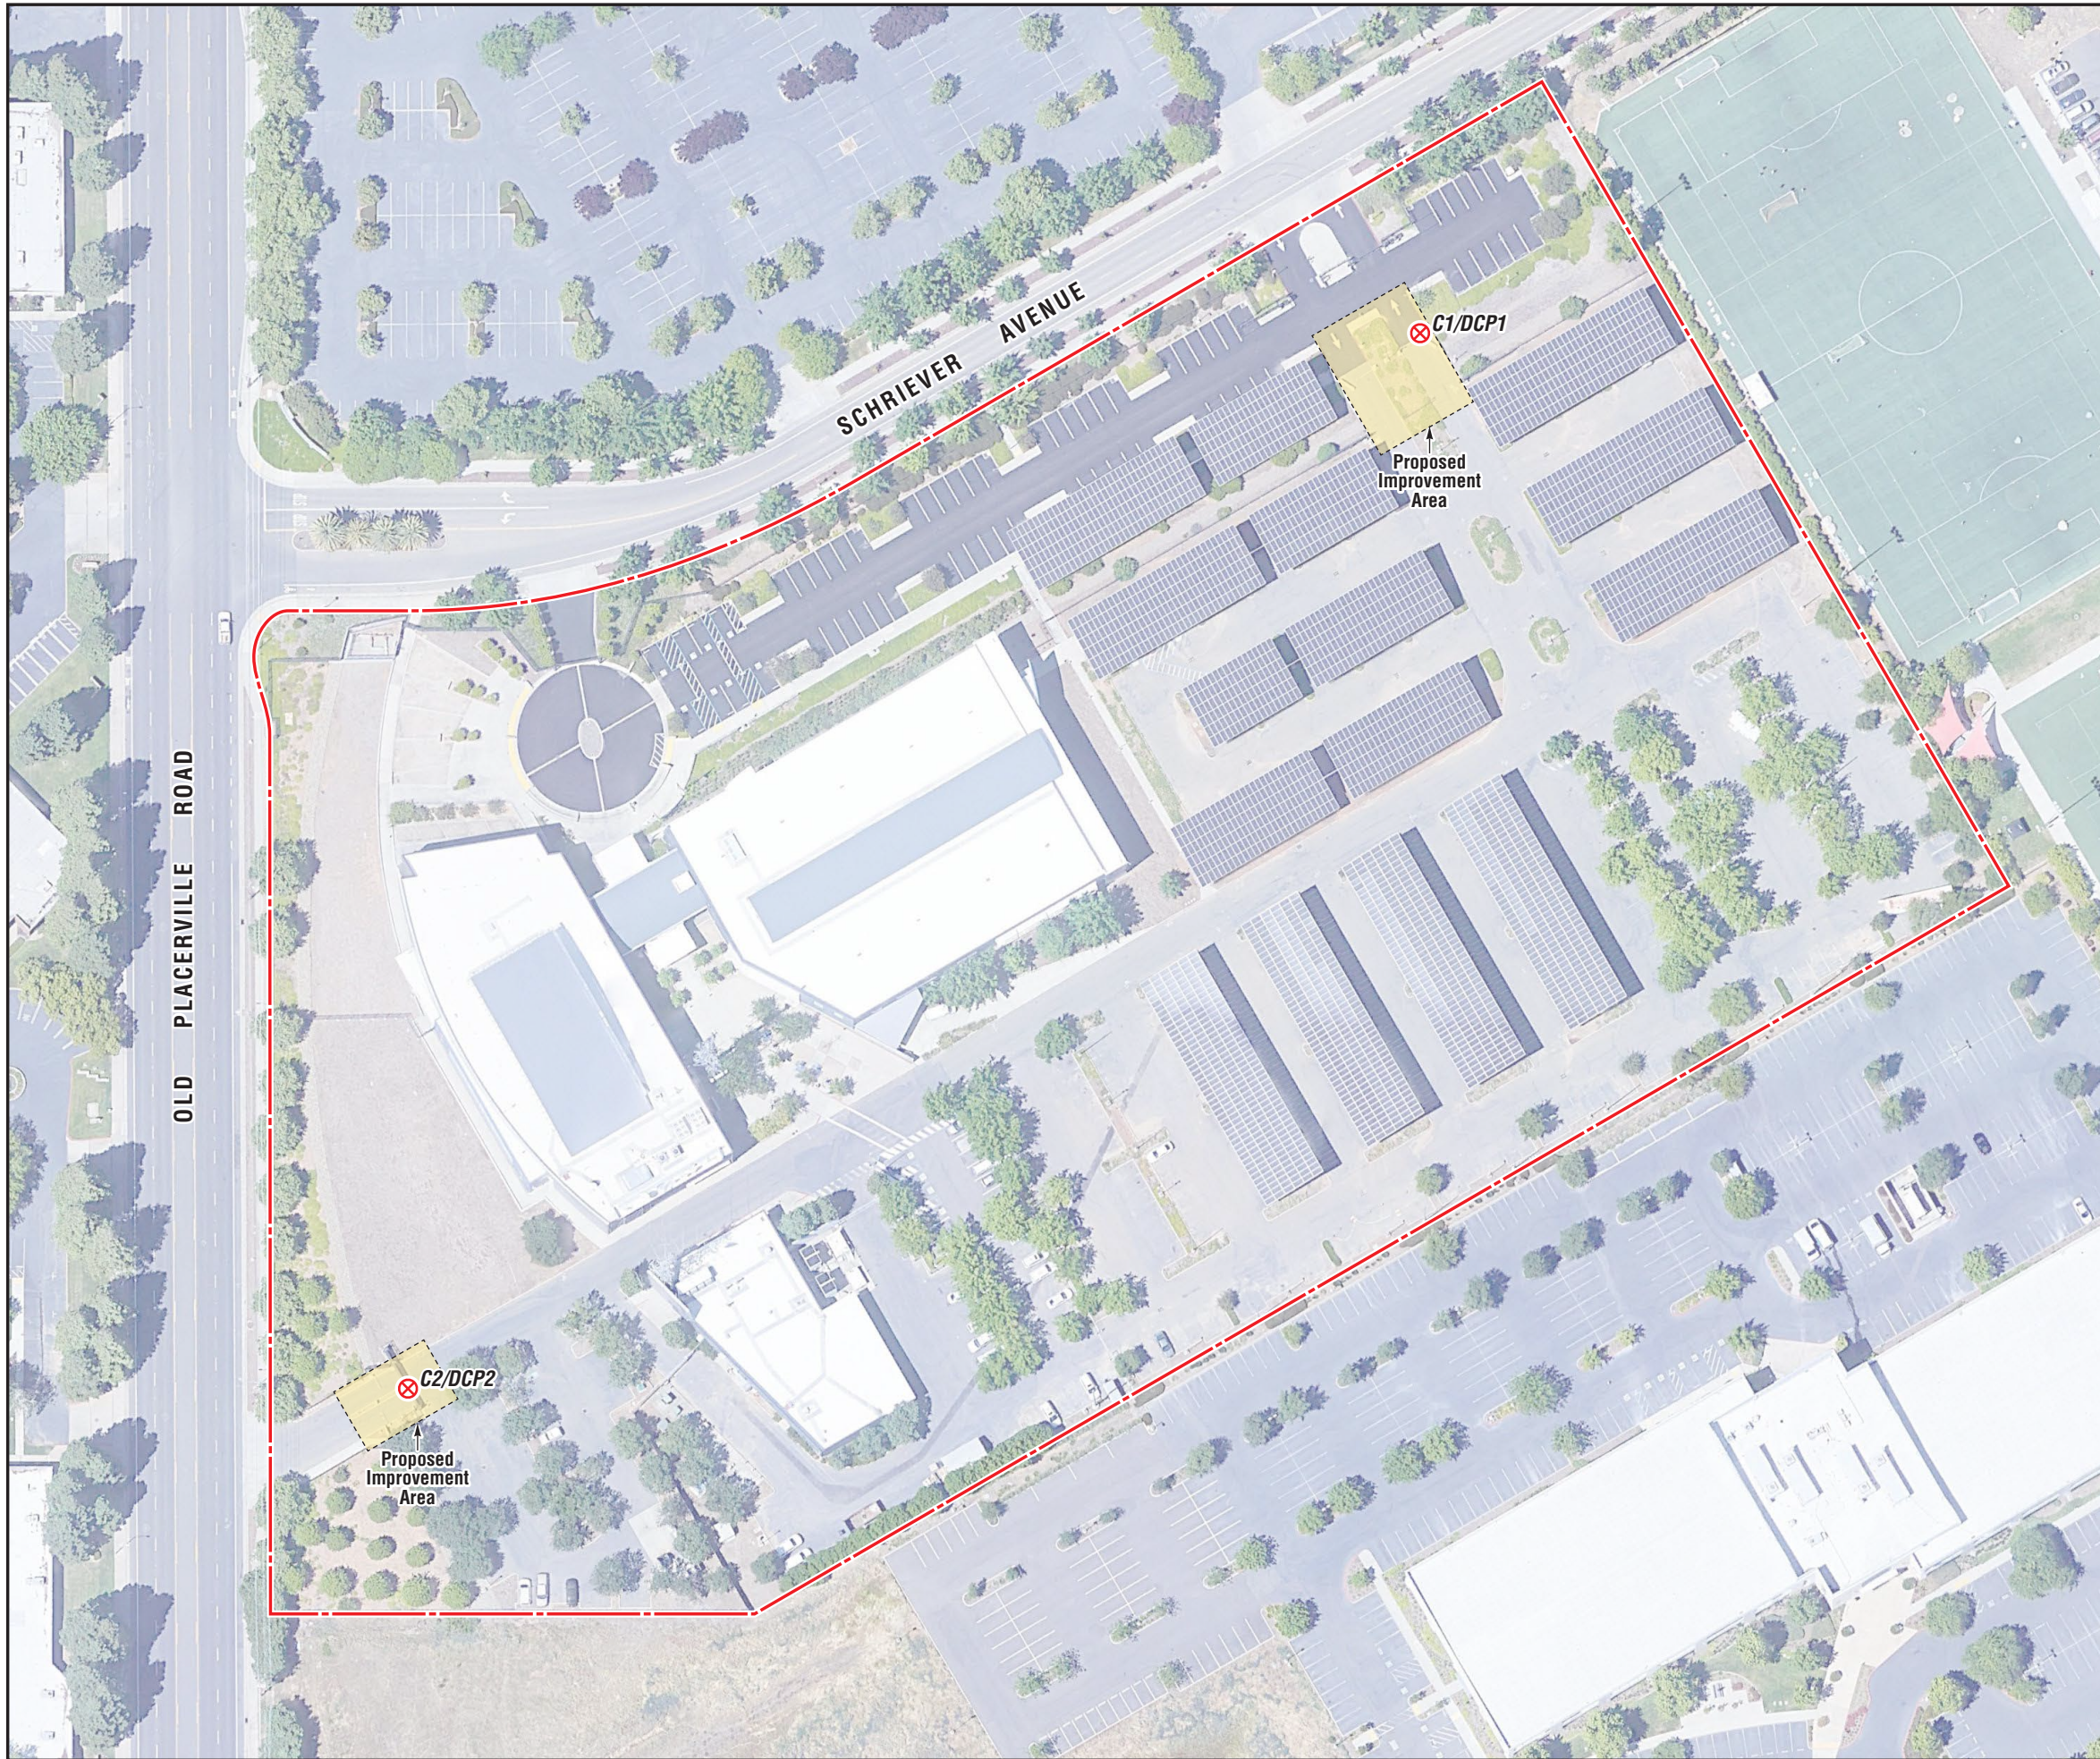
Figure 2

LEGEND:

- Approximate Site Boundary
- C2/DCP2* X Approximate Core Location

- Performed two pavement cores (C1 and C2), one at each proposed improvement location, and measured the existing pavement section thickness. Approximate core locations are shown on the Site Plan, Figure 2.

The project consists of installing new security gates and guard kiosks at the two entrance and exits drives. The new security gates will likely consist of barrier arms secured to shallow foundations. The new guard kiosks will likely consist of a small ballistic rated structures supported on shallow concrete footings. The current site configuration, with proposed improvement areas outlined, is shown on the Site Plan, Figure 2.
